**GARFIELD AVENUE**

**STUDY AREA**

***“A Non-Condensation Redevelopment Area”***

**February 17, 2015**

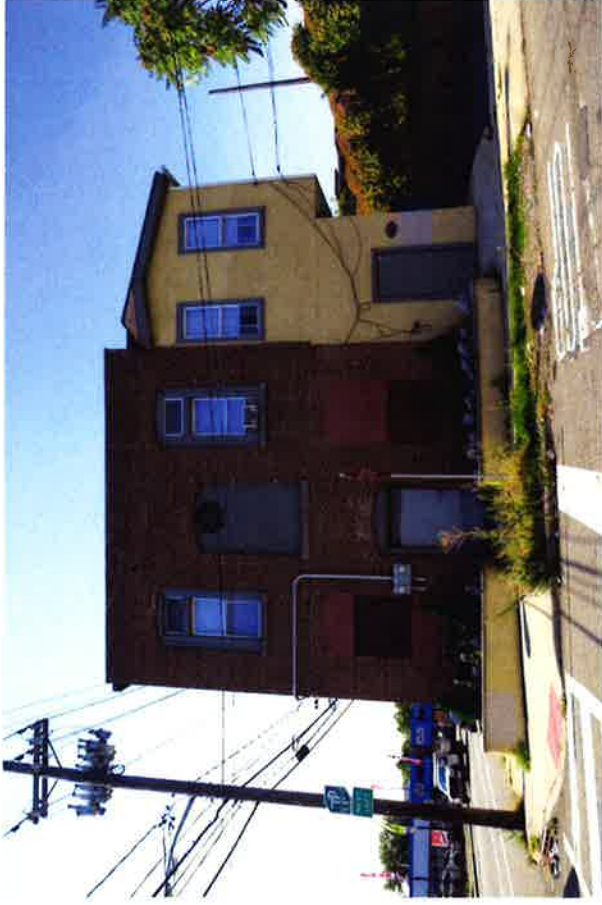
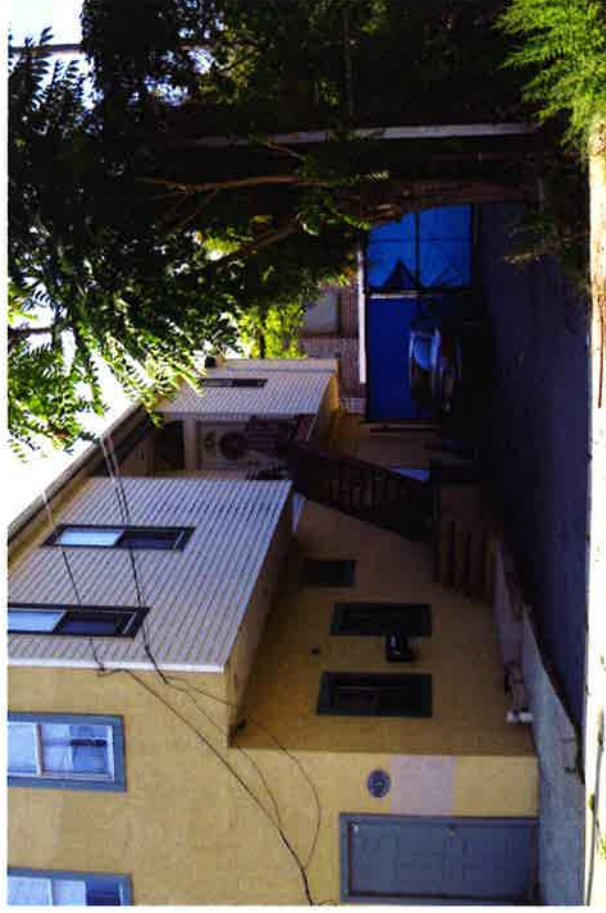
Block 23701 Lot 7 (from Wilkinson Ave)

This site contains a two-story masonry and frame industrial structure in fair condition. The driveway has a tall chain link fence allowing access to the rear yard in excess of fence height standards. The side door lacks a railing to the first landing. The rear yard of this building is unkempt, with broken paving, weeds, and debris strewn about. The sidewalks surrounding the building are in disrepair with weeds growing up between the cracks and littered with electronic waste and other refuse. Several windows are haphazardly hung and improperly sealed. A masonry fence along the Garfield Avenue frontage is covered with graffiti. This lot meets criteria "d."

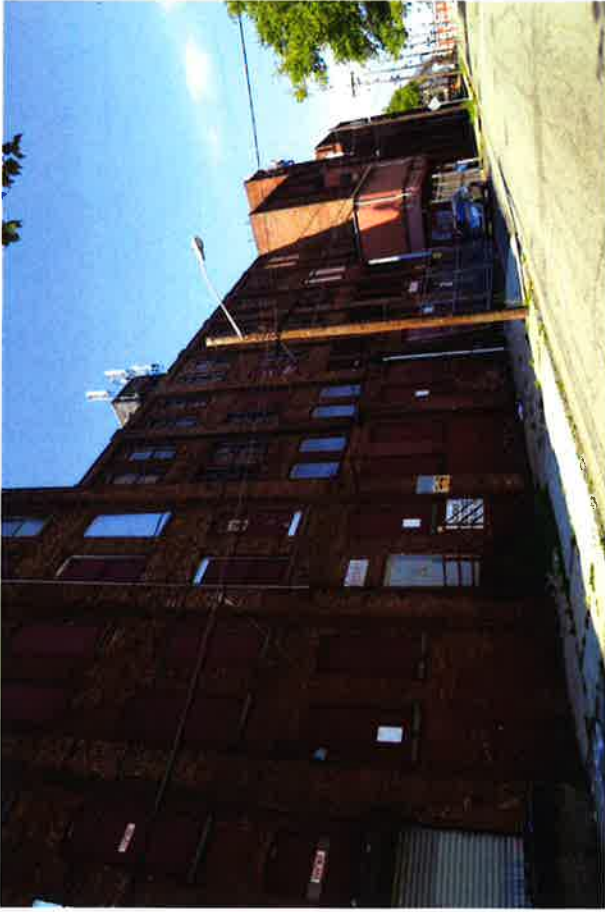
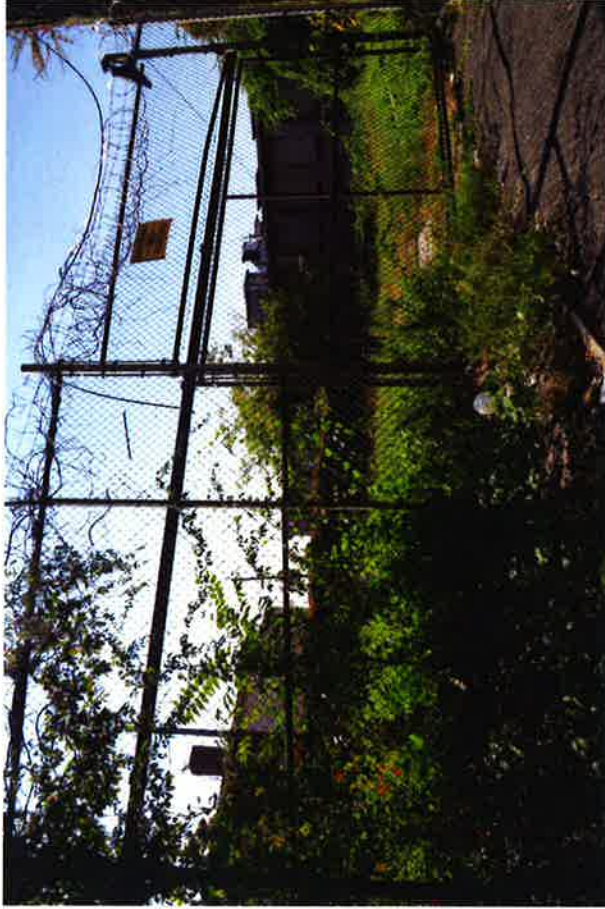
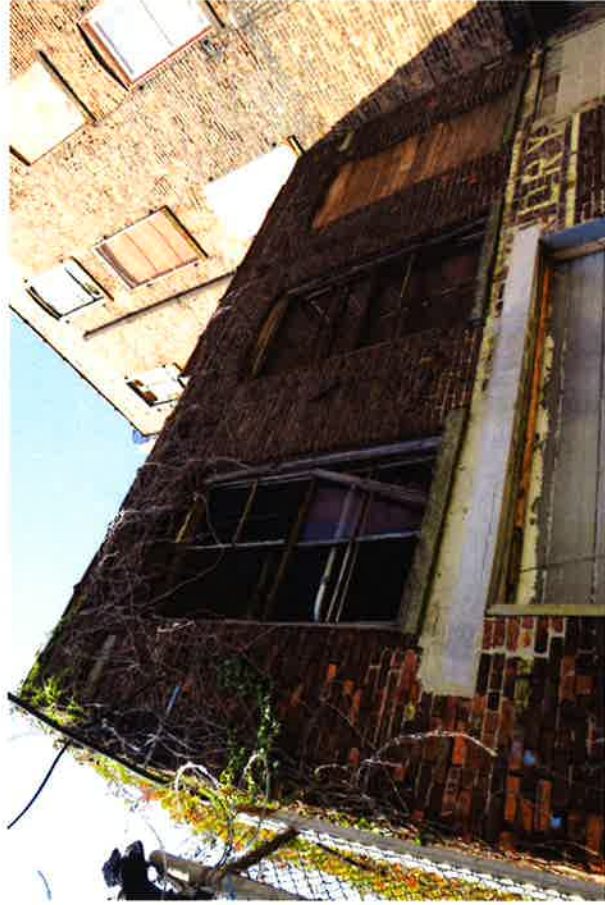
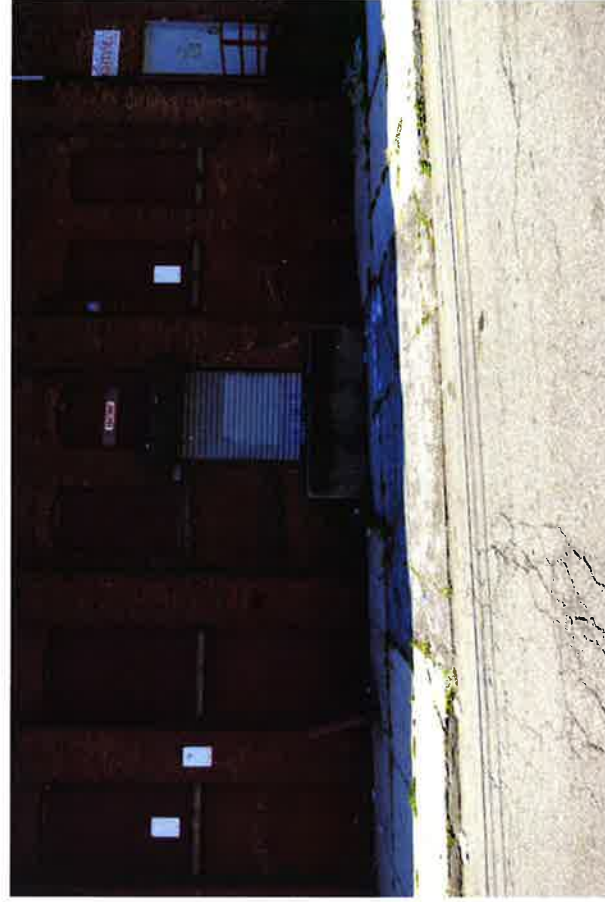
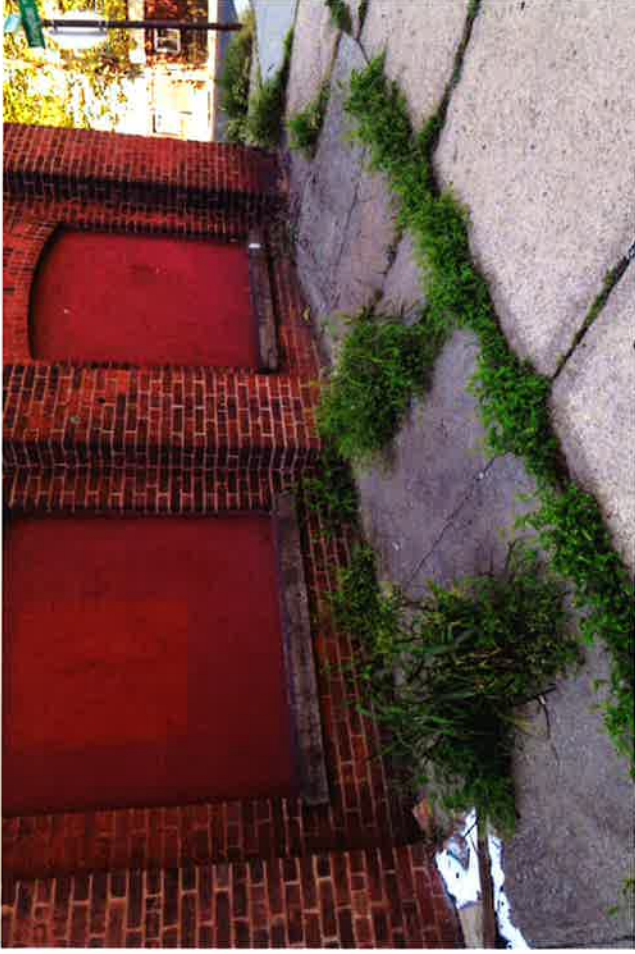
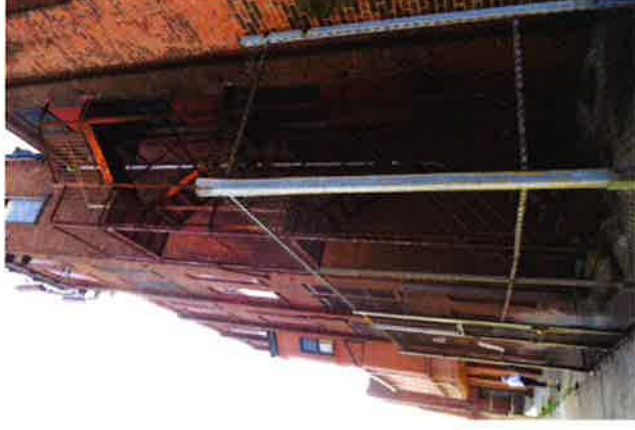
Block 23701 Lot 6 (from Wilkinson Ave)

This site contains three structures on a corner lot. More than one principal structure on a single lot is prohibited in the R-1 zone. The largest structure is a four- and five-story masonry industrial building in poor condition. Windows are either broken and open to the elements, boarded and painted to match the brick façade, or a mix of intact old and new windows. Weeds have grown where the building foundation meets the sidewalk as well as through seams throughout the sidewalk. Trash is also strewn about the sidewalk along both street frontages. An exterior stairwell fronting Wilkinson Avenue is in disrepair and enclosed with chain link fencing. Several curb cuts and loading bays front the street and lack adequate paving and drop aprons. Slate curbing is deteriorated and crumbling into the cartway. The other two, smaller structures are both two story masonry industrial buildings in poor condition. Sited behind the larger structure, these buildings are placed away from the street. If either smaller structure is categorized as an accessory structure they will exceed the height limit of fifteen (15) feet in residential zones. The smaller buildings are covered in vines and missing most windows, exposed to the elements. Both smaller buildings have several cracks to the foundation and below the windows. The rear yard, parking, and loading areas are enclosed by a chain link fence with razor wire which is prohibited in a R-1 zone. The fences are also in excess of maximum height standards. The rear yard and enclosed parking area is unkempt, with broken paving, weeds, and debris strewn about. This lot meets criteria "a," "b," and "d."

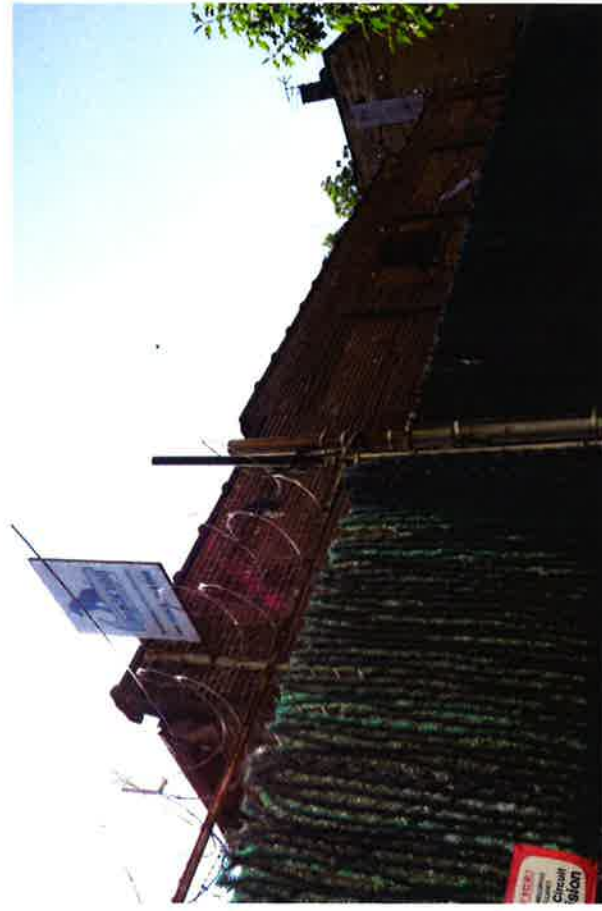
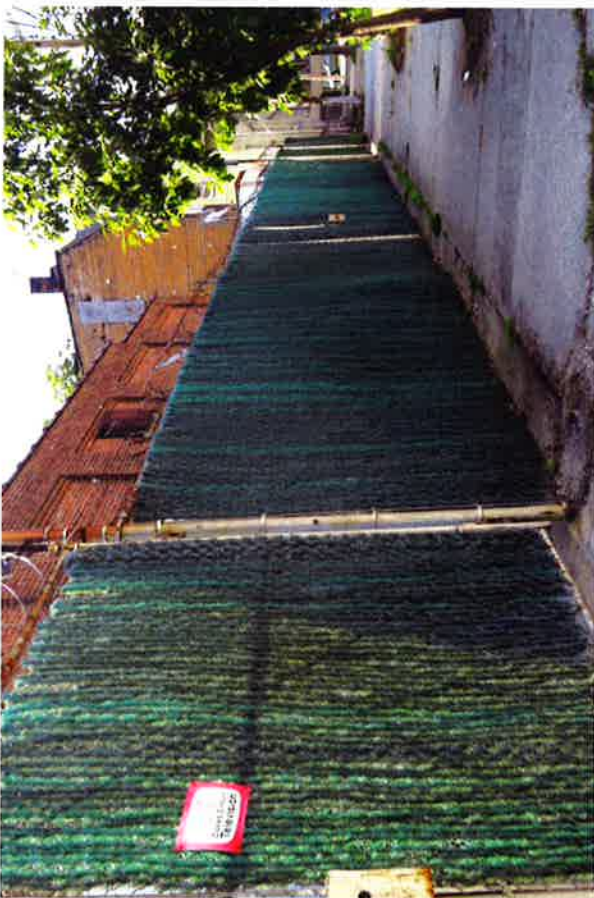
Block 23701 Lot 5

This site contains a one-story masonry commercial garage building in fair condition. The property is enclosed by a tall chain link fence woven with faux vines and topped with barbed wire and razor wire – prohibited in an R-1 zone. Although there are two street trees, the sidewalk is in disrepair with weeds growing up between the cracks and in tree pits. Two curb cuts lack adequate paving and drop aprons. This lot meets criteria "d."

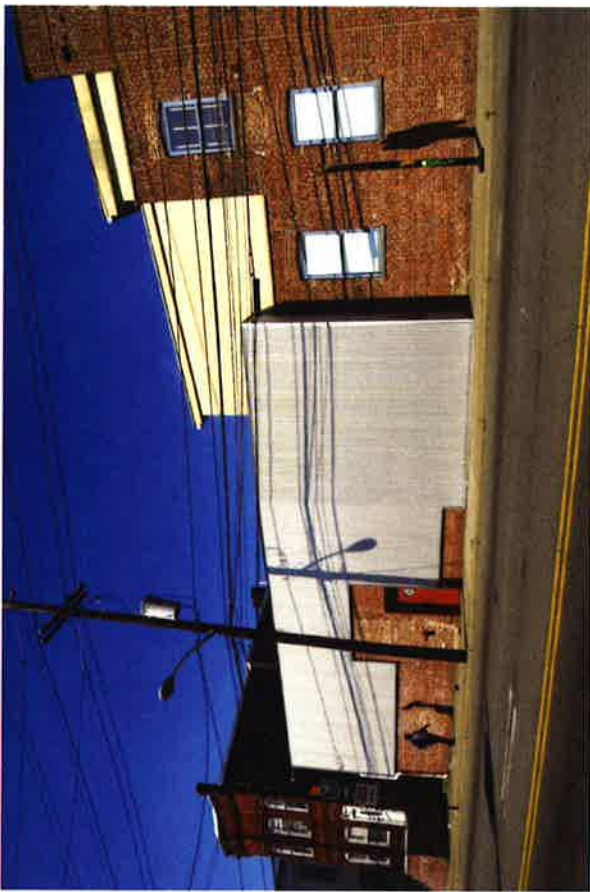
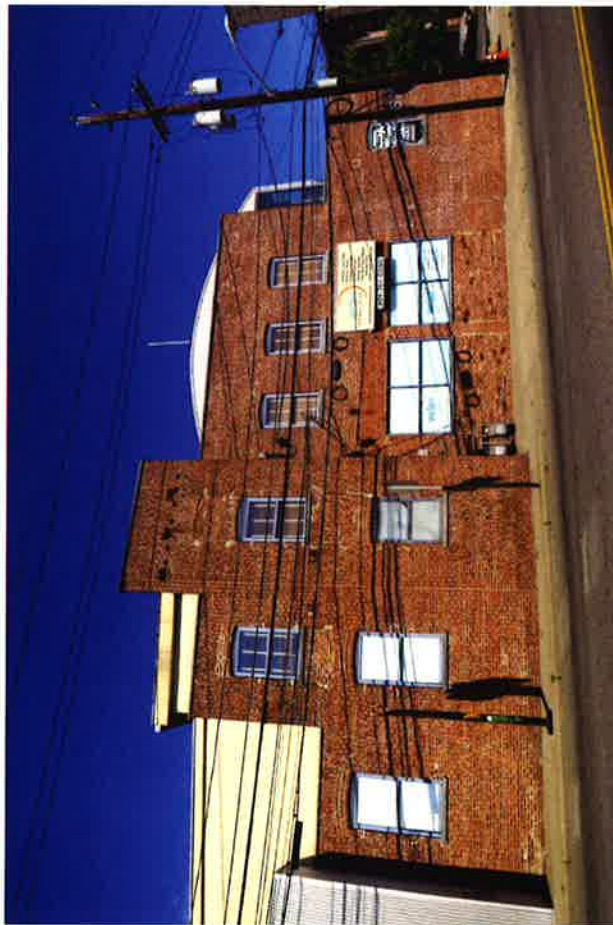
Block 23701 Lot 27 (from Garfield Ave)

This site contains a two- and three-story masonry building with a glass and metal addition in good condition. Formerly industrial, the building was repurposed as office and a senior center. The building takes up nearly 100% of the lot when only 60% building coverage is permitted. There is no landscaping along the main street. The side street is landscaped with ground cover, sculptures and street trees that are well maintained. The sidewalk is in good condition without cracking, weeds, or debris.

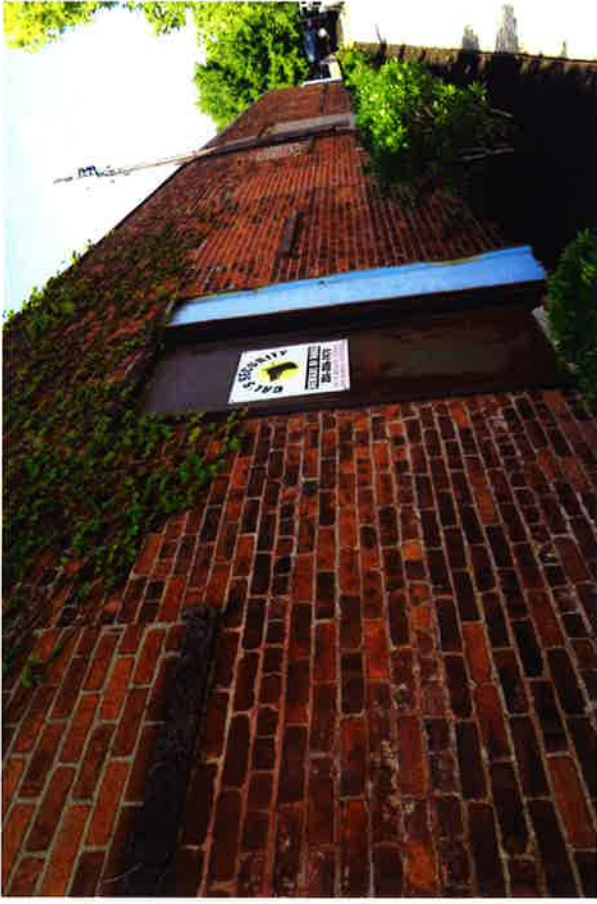
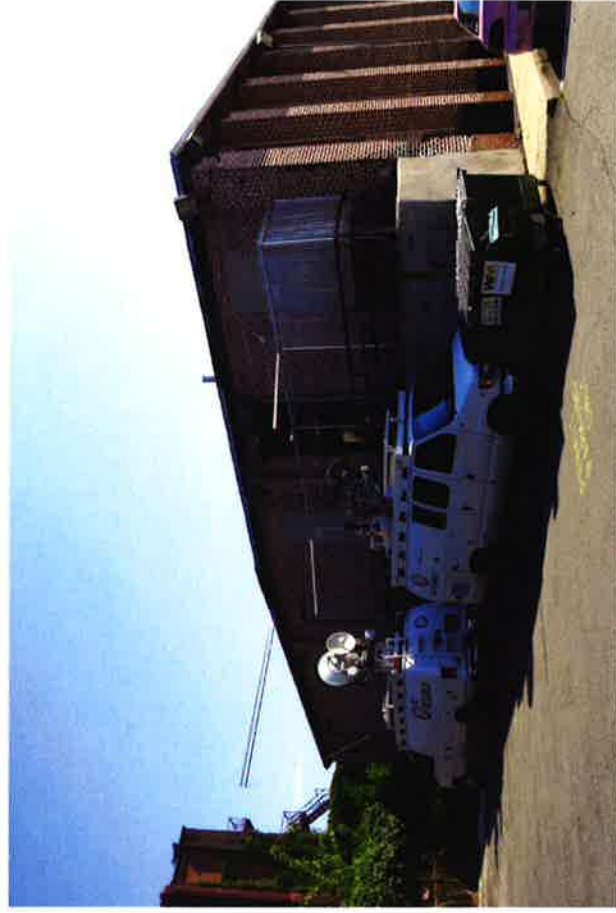
Block 23701 Lot 28

This site contains a 1-story masonry industrial building in fair condition. The building has bricked up windows and a boarded clerestory that is sealed to the elements. Landscaping is nicely designed and well maintained. An easement for public access is gated and locked. The sidewalk is good condition and no debris is found on or surrounding the site. This lot meets criteria "d."

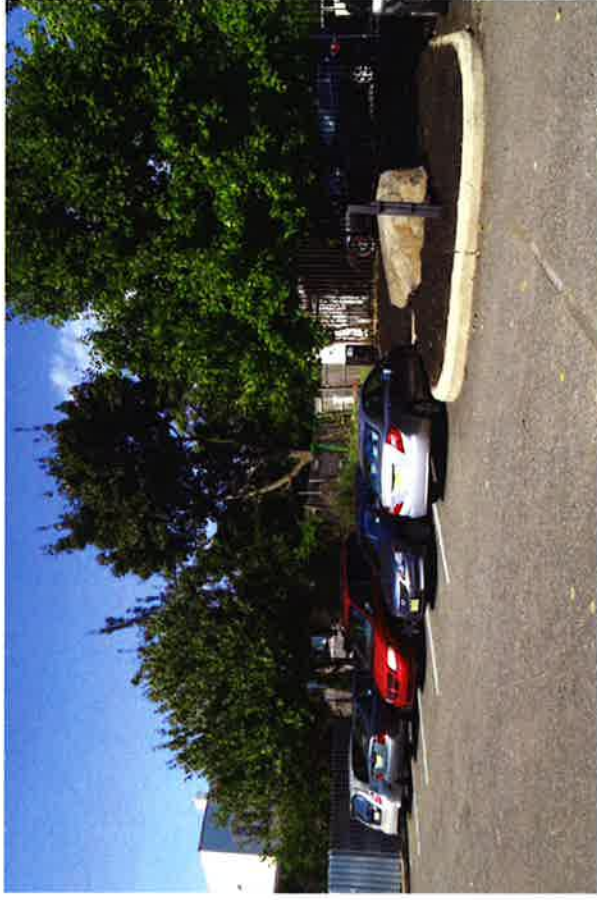
Block 23701 Lot 29

This site contains a parking lot with improvements in good condition. Improvements include curbing, lighting, striping, and refuse area enclosed with metal fencing. Landscaping is well maintained along Marcus Street. The area and planting strip adjacent to the refuse area is overgrown with weeds and littered with debris.

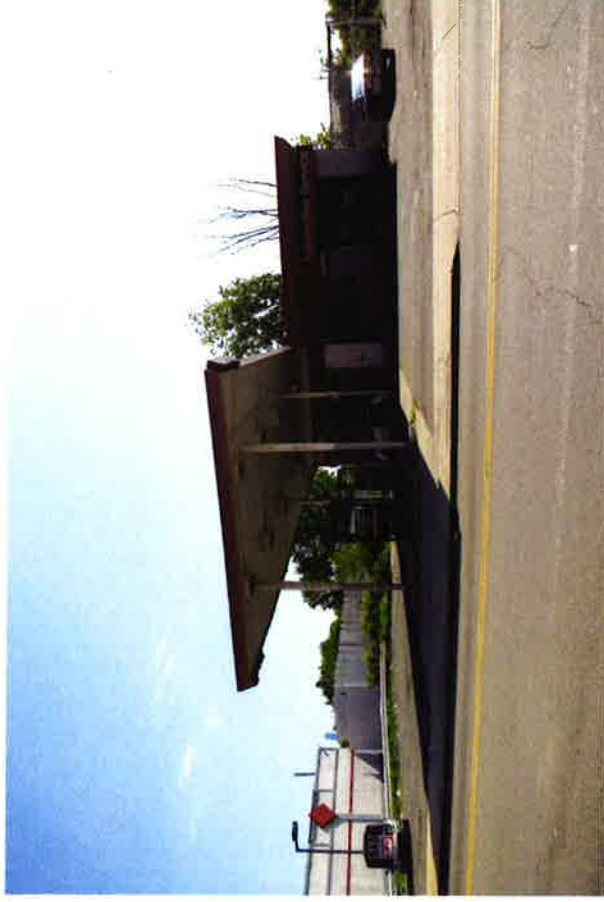
Block 23704 Lots 1, 2 & 3

This site contains a gas station with a one-story masonry auto garage and station awning in poor condition. The station is vacant and appears abandoned. There is an open permit to remove, clean and dispose of one (1) 550 gallon Underground Storage Tank (UST). The pumps are broken and missing equipment. Several cars look to be illegally parked or abandoned on site. The pavement is cracked and weeds are growing through the cracks. Debris is strewn about the site. This lot meets criteria "a," and "d."

This site is situated behind block 23704 Lot 1, is land-locked and has no access to an improved public right-of-way, fronting only a paper street named Commercial Street. A chain link fence encloses the site which is unpaved, unkempt, and full of dirt piles and weeds. These lots meet criteria "c."

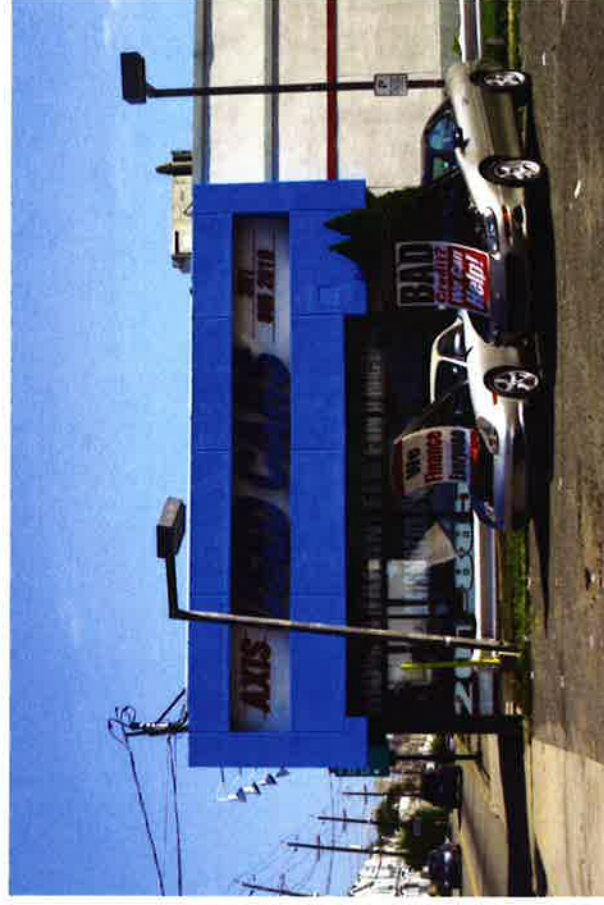
Block 23704 Lot 4

This site contains a one-story stucco, steel and glass structure located on the southwest end of a large lot in fair condition. The building has large building signage and banner signage in excess of regulations. Although the building does not appear to have any structural issues it stands in stark contrast to the old masonry buildings across the street. The large lot that makes up the majority of the property is in poor condition. Both the sidewalk and the on-site pavement is cracked and deteriorating, overgrown with weeds. The rear and side lot lines have chain link fencing reinforced with graffitied corrugated iron that is topped with razor wire. These lots meet criteria "d."

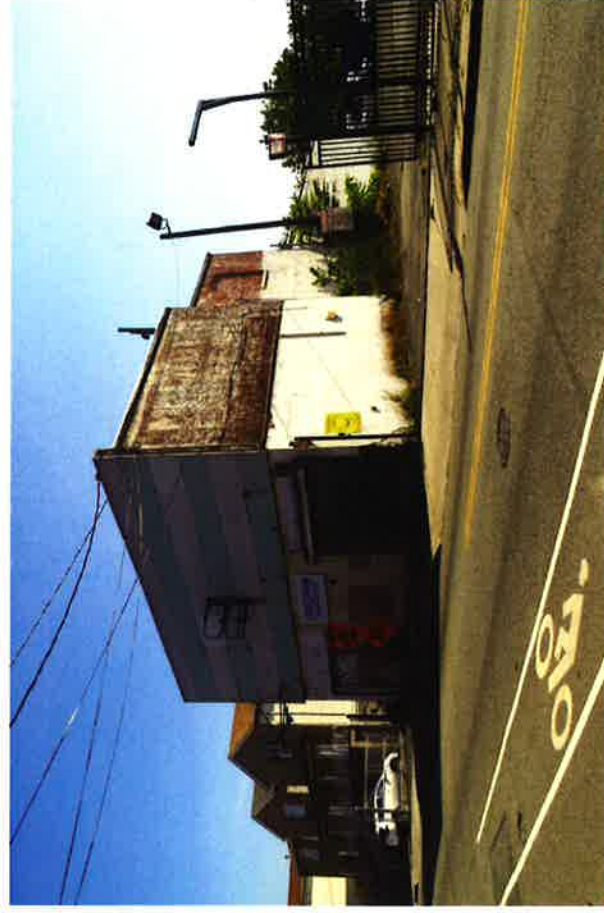
Block 23701 Lot 8

This site contains a two-story masonry industrial building in fair condition. The rear loading area has no drop apron. The refuse area next to the sidewalk on Marcus Street is not screened. There is chain link fencing in the rear loading area and along the lot fronting Garfield Avenue. Many windows are cemented and sealed to the elements. The side yard has cracked pavement, weeds and, an overall abandoned look. The sidewalk along Garfield Avenue is broken and weeds are growing between the cracks. Debris also litters the sidewalk. A loading area fronting Garfield Avenue near the intersection of Marcus Street has a mountable curb with improper drop apron. The sidewalk in front of the garage doors has a mountable curb, lacking a proper drop apron, designed for sidewalk loading and unloading. This lot meets criteria "a" and "d."
